Shield Technologies Corporation
3225 Neil Armstrong Boulevard
Suite 300
Eagan, MN 55121

SUBJECT: USMC AAV Envelop Protective Cover Validation Test

USMC AAV TURRET ENVELOP PROTECTIVE COVER VALIDATION TEST

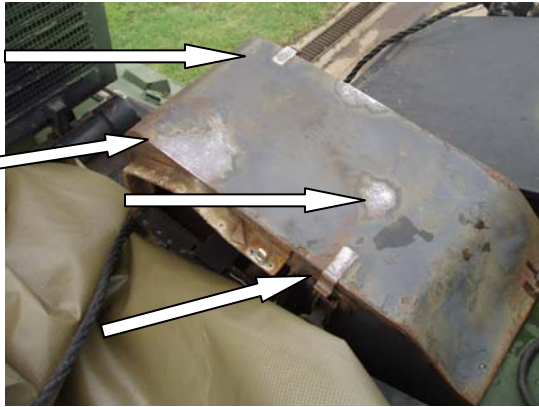
Corrosion ground off in these areas.

Arrows indicate areas of the manlet where corrosion was ground off July 11

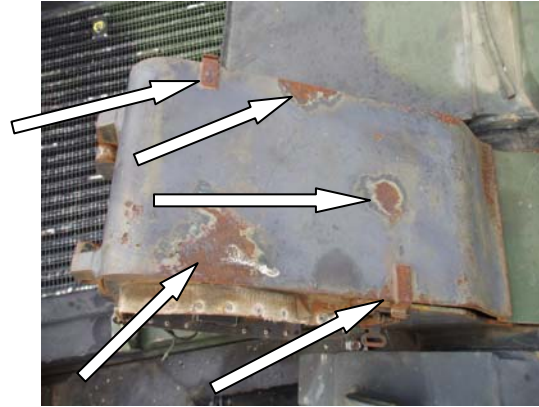
The control unit (#109) showed considerable new corrosion on all ground surfaces. This is normal corrosion for 1 month period of time in Hawaii.

Ground manlet of control unit on Aug 11. Arrows indicate corrosion forming during test period

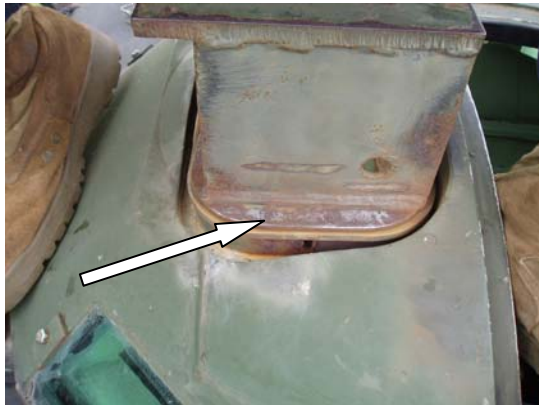
Corrosion ground off in this area.

Ground edge of site housing on Control: July 11

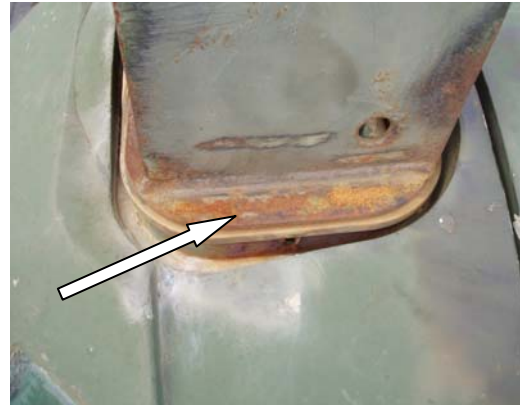
Ground edge of site housing on Control: Aug 11

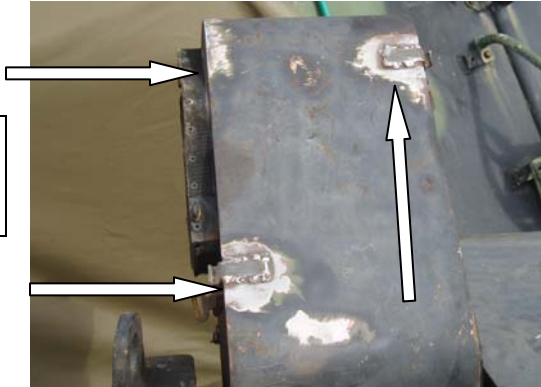
Corrosion ground off in these areas.

Ground down areas on Manlet on #110: July 11

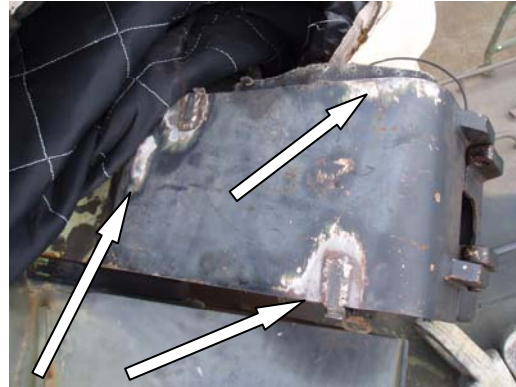
The ground areas of the manlet were clean with minimal change from the initial pictures of one month ago. The ground portion of the eyelet was also clean of any corrosion. Compared to the control unit, less than 5% of the corrosion was evident on unit #109. Please see comparative pictures 2.

Same areas of Manlet on #110: Aug 11

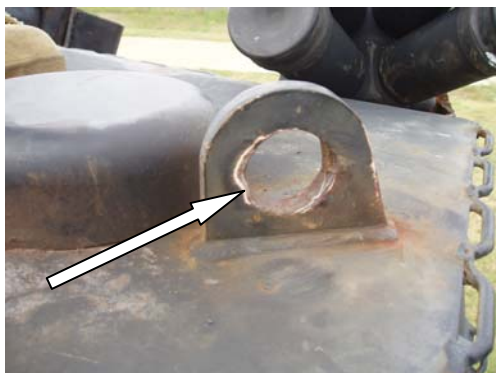
Corrosion ground off this area.

Ground Eyelet on #110: July 11

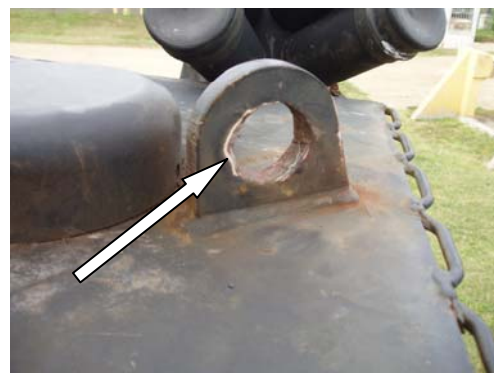
Eyelet on #110: Aug 11

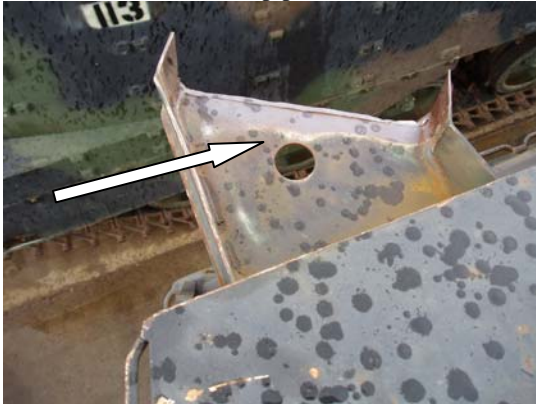
Corrosion ground off on this area.

Ground "broken" attachment for smoke grenade
July 11

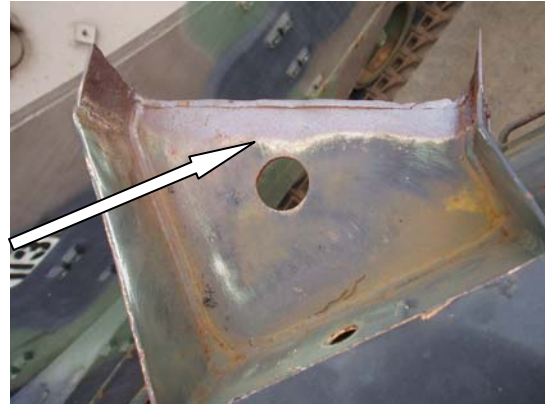
The ground area on the bracket for the smoke grenade launcher had very small evidence of corrosion. There was slightly more corrosion on the ground surfaces of the site housing. The smoke grenade bracket contained less than 5% of the corrosion found on the control unit and the top of the site housing had 10-15% of the corrosion found on the control unit. Please see comparative pictures 3. The Marines said that they did remove this cover a few times during the month for maintenance reasons.

Ground "broken" attachment for smoke grenade
Aug 11

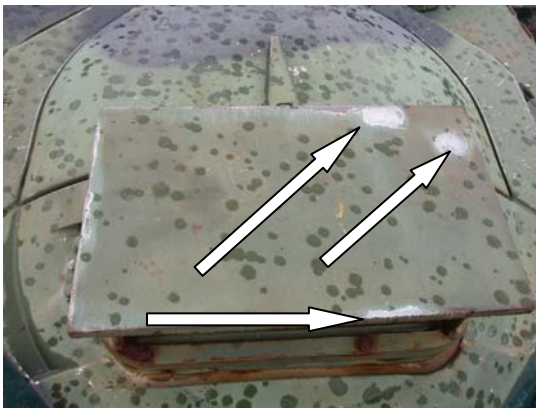
Corrosion ground off at areas indicated by arrows.

Ground surface of the site housing on July 11

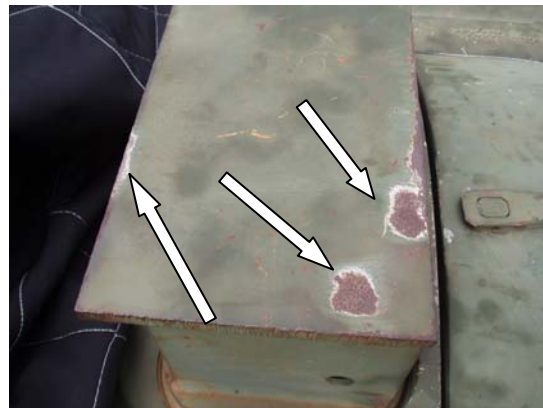
Ground surface on the site housing on Aug 11

The site housing was not protected as thoroughly as other sections due to the use of ballistic nylon to protect the internal components of the cover from the sharp edges of the site housing. This further validates the "wicking effect" of the quilt portion of the Envelop cover. Production covers will be designed to protect all metal objects with the same equal protection.
