ENVELOP FIELD TEST ON THE M777 LIGHTWEIGHT HOWITZER

1. The joint artillery training team at Fort Sill OK, tested the Envelop protective cover on a M777 155 mm howitzer to evaluate the effectiveness of the cover over an extended storage period.
2. The cover was installed on the M777 in November, 2005. The weapon was parked outside and was not “opened” nor was any maintenance performed on the weapon for 5 months.
3. The cover was removed on April 18 and the weapon was found to be in the same state as when it was covered in November. This is in contrast to ferrous metal lifting/tie down shackles that were outside of the cover and had substantial rust and corrosion. Following is a quote from the uniformed staff at Fort Sill:

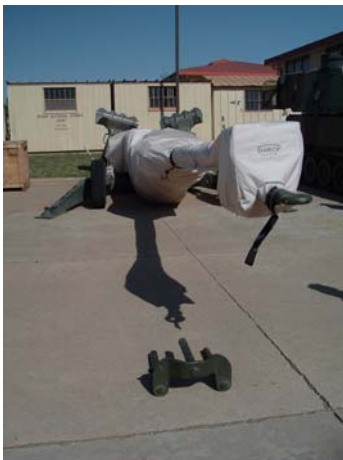
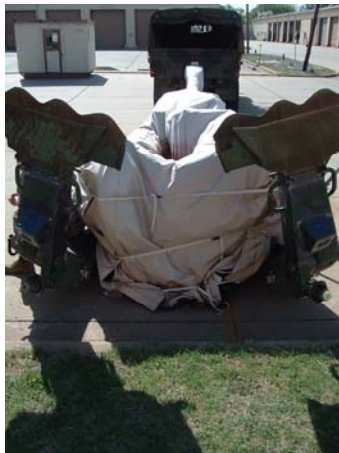
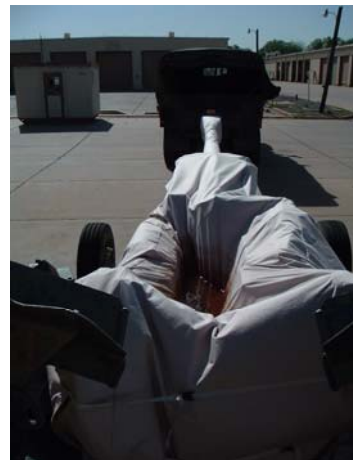
There was no new rust on the weapon system that was under the envelope cover. It rained approximately 5 times and snowed twice. We did not remove the cover at all during this period. The cover itself retained water on the outside but did not allow it to reach the weapon. The weapon was inside the envelope cover from temperature ranges in the low teens to 105 degrees. No condensation was built up on the inside of the cover.

Pictures of the M777 covered with the Envelop protective cover.

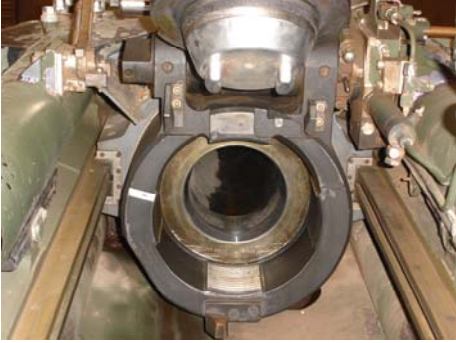
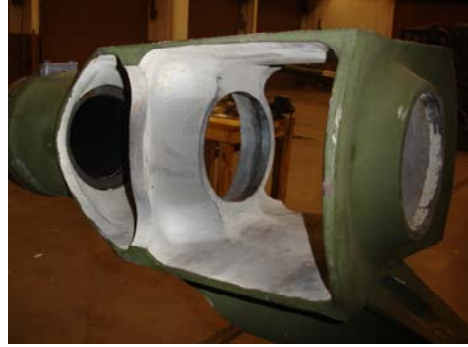
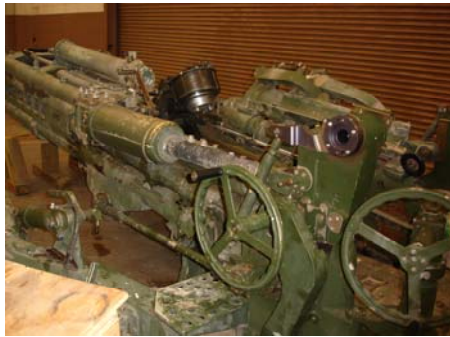
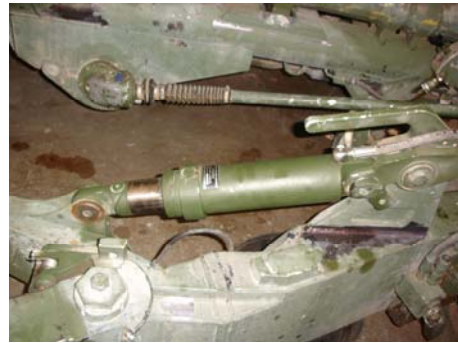
The barrel, muzzle breach and other components were in the exact same state after the 5 month test.

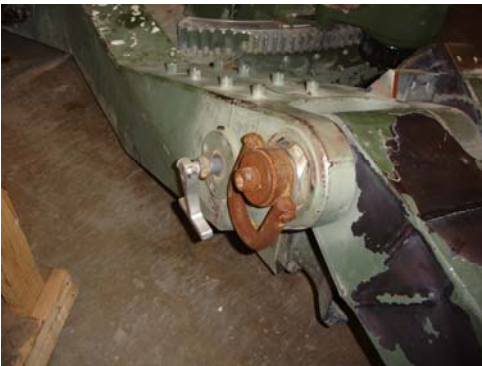
There were a few ferrous metal lifting/tie down shackles that were not covered by the Envelop test cover. The ring shows the level of corrosion that occurred when not protected with the Envelop cover.
