**Visit Report
USS SWIFT (HSV 2)
18 August 2005**

On the 18th of August I paid a routine visit to the USS SWIFT (HSV 2) in her homeport of Ingleside, Texas. The ship had just returned the evening before from a 19 day exercise in the waters around Panama in support of a joint forces training mission. My point of contact for this visit was the ship's Bos'n, CWO4 Steve Pelon, USN (Blue Crew).

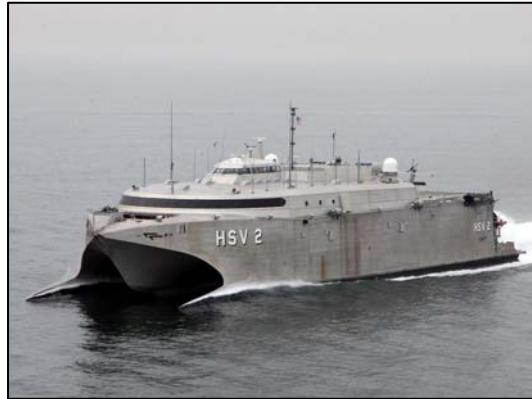
Figure 1. USS SWIFT (HSV 2)

The USS SWIFT (Fig 1.)is a 321 foot high sped wave-piercing catamaran constructed of aluminum and is capable of speeds in excess of 45 knots (53 MPH). She is manned by a crew of 42 persons operating in a Blue & Gold rotation. At this time she is assigned as a Mine Warfare Support Ship, however she also participates in various other assignments in support of various military missions. Recent operations have included Tsunami relief in Southeast Asia, counter drug operations in the Caribbean, and the recent joint forces training in Panama. The weapons systems on the vessel are

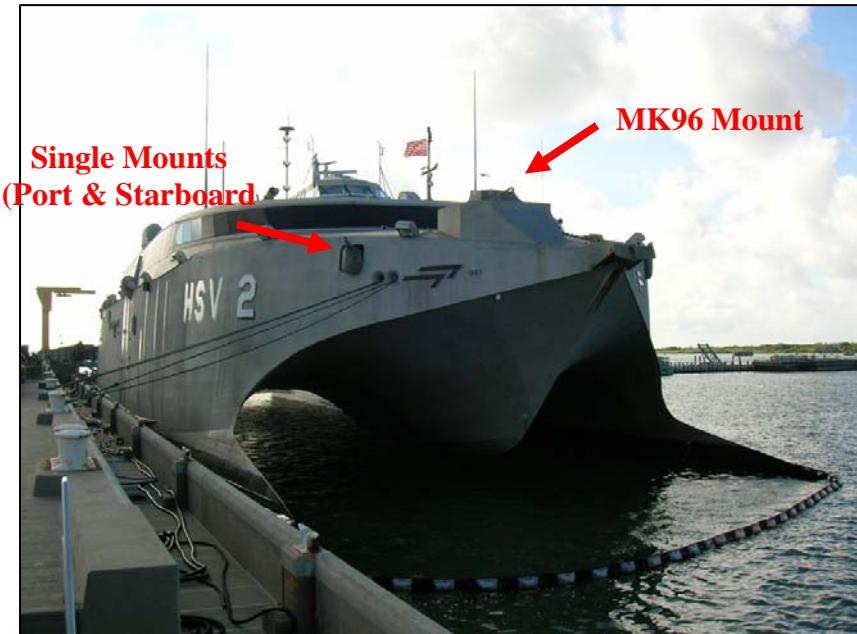
Figure 2 USS SWIFT Forward Mounts

The SWIFT has various gun mounts around the exterior of the ship as indicated in the below photographs. (Figs 2 & 3)

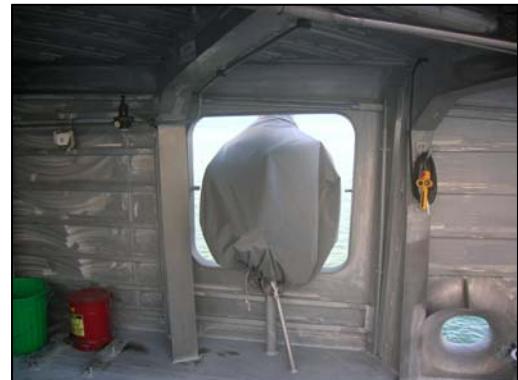
Figure 4 USS SWIFT Forward Port Mount

During the 18 August visit I was met by CWO4 Pelon and introduced to the ship's Commanding Officer. During the brief introduction the CO indicated that he was very happy with the performance of our three gun mount covers currently on the ship. I then accompanied CWO4 Pelon to the forward area of the ship to look at the covers on the .50 Cal mounts. I had noted that when approaching the ship the twin .50 Cal guns were mounted on their mid-ship flight deck mounts but that they were not covered. When we arrived at the forward .50 single mounts I found that they had placed the two twin .50 Cal covers on their single .50 Cal mounts. (Fig 4.) CWO4 Pelon explained that even though the covers were designed for the twin mounts they chose to use them on the single mounts because of their location in the bow and because these guns had been mounted the entire time the ship was deployed. Because of helicopter evolutions the twin mounts were not always up on deck.

The ships' GM1 explained that the guns had been placed in their mounts prior to departing for the exercise, had all of the required Preventative Maintenance (PM) completed, and were in good working and material condition. The ship then transited from the continental United States over 1500 nautical miles to the Panamanian Operations Area (OPAREA) at speeds averaging 40 knots. During the transit the covers were subjected to high winds, salt spray and occasional rain. Once in the OPAREA the guns remained mounted the entire time during which they were subjected to daily rain winds exceeding 40 knots, continuous high humidity and temperatures frequently in excess of 100 degrees. The guns were fired several times during the exercise and received normal post-fire PM after each shoot. Following the exercises the ship transited 1300 miles back to Ingleside with the guns and covers in place, arriving the night prior to my visit.

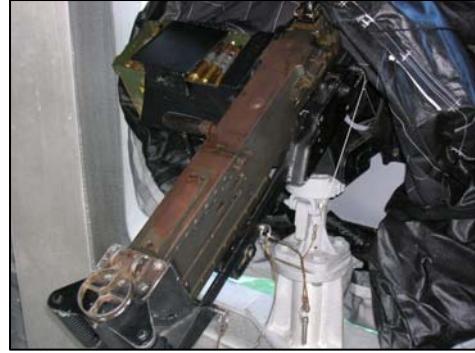
Figure 5 USS SWIFT Forward Port .50 Cal

The cover on the forward port gun mount was removed (Fig 5) and the condition of the gun was observed to be in a very good state of preservation. There was evidence of prior corrosion on top of the gun's receiver which had left a brown tint to the metal; however there was no new rust, corrosion, or salt deposits evident on the gun. All of the applied lubrication was still in place on the gun. The GM1 explained that the guns had last been fired about nine days prior to my visit and had been covered since the post-fire PM. The accompanying photo shows the material condition of the gun. The brown coloring on top of the receiver is from the effects of previous corrosion removing the Parkerizing material from the surface of the gun. Having conducted over 200 material condition reviews of this type of gun in my 29 year military career, in my opinion these guns were in outstanding condition considering the extreme operating conditions they had been subjected to over the previous 19 days.

Additionally by observation the cover appeared to be in outstanding material condition considering that it is in fact too large for the mount it was being used on and the sever environmental conditions it had been exposed to in the recent past. The two draw backs the GM1 pointed out with the cover was that because of the mounts location in the bow (Figs 2 & 4) and that it protrudes through a relatively small opening in the skin of the ship it was at times difficult to get the cover over the end of the gun barrel. The other draw back was that the front sight on the gun has a sharp point on top which stuck into the cover material. This problem was temporarily solved by removing the sight when the cover was in place.

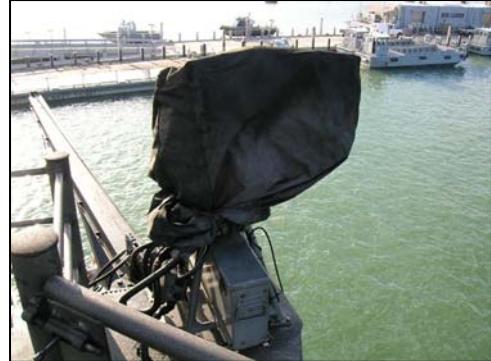
Figure 6 USS SWIFT, MK45/EX45 Mount looking aft

We next took a look at the cover placed on the MK45/EX45 40MM mount (Figs 6 & 7)on the after port side of the flight deck. This gun mount is a remotely operated mount which is placed outside the safety railing on the edge of the flight deck. This places the mount directly aft of the ships main engine exhaust port which in turn subjects the mount and cover to excessive stack gasses and smoke. I was told that previous covers placed on this mount had lasted less than 30 days once the ship got underway because of the corrosive effects of the exhaust gasses and the winds the cover is subjected to. Our cover had been in place over 90 days so far and was holding up well. Because of this location the cover was almost entirely black as it had not yet been cleaned. CWO4 Pelon reported that even with the cover becoming as dirty as it was (Fig 6.), it cleaned up very easily with soap and water as the instructional DVD indicated it would. Additionally during July 2005 this cover was left in place over the mount during a 30 day dry dock availability in Louisiana where daily sandblasting, painting, and extreme weather conditions were present.. The cover suffered no damage or deterioration in the shipyard environment.

The GM1 indicated that the cover on the MK45/EX 45 was mounted during the entire Panamanian operation and was even left in place during helicopter evolutions where it was subjected to the rotor down wash from a HH60 helicopter on a daily basis. It was only on the last day of the exercises that there was some concern that the cover would blow off and be lost so it

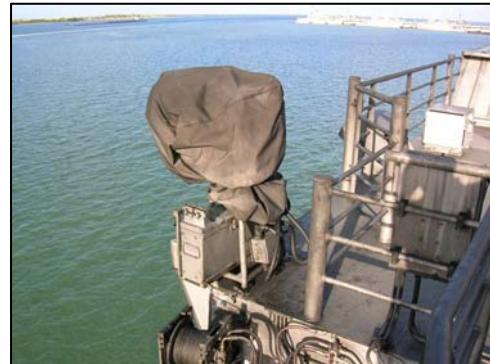
Figure 7 USS SWIFT MK45/EX45 Mount looking forward

Of note, the cover used on the EX45 mount is not designed for this particular system. The 40 MM MK19 cover we designed was intended to be used on a universal MK93 mount which is not remotely operated. Because of the cabling attached to the EX45 the over does not fit properly and leaves some of the cabling and the ammunition box constantly exposed to the weather. (Fig 7)
