Shield Technologies Corporation
3225 Neil Armstrong Boulevard
Suite 300
Eagan, MN 55121

SUBJECT: USMC AAV Envelop Protective Cover Validation Test

USMC AAV TURRET ENVELOP PROTECTIVE COVER VALIDATION TEST

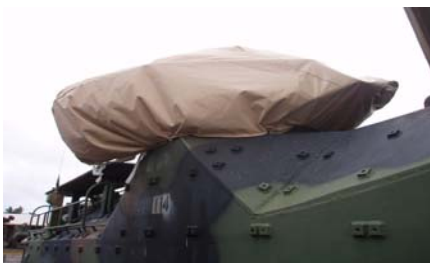
Envelop cover on #114

The ground area on the bracket for the smoke grenade launcher had very small evidence of corrosion. There was slightly more corrosion on the ground surfaces of the site housing. The smoke grenade bracket contained less than 5% of the corrosion found on the control unit and the top of the site housing had 10-15% of the corrosion found on the control unit. Please see comparative pictures 3. The Marines said that they did remove this cover a few times during the month for maintenance reasons.

The site housing was not protected as thoroughly as other sections due to the use of ballistic nylon to protect the internal components of the cover from the sharp edges of the site housing. This further validates the "wicking effect" of the quilt portion of the Envelop cover. Production covers will be designed to protect all metal objects with the same equal protection.
